Engineering Case Library

Development of a Dynamic Seal

Beckman Instruments, Inc. - Spinco Division

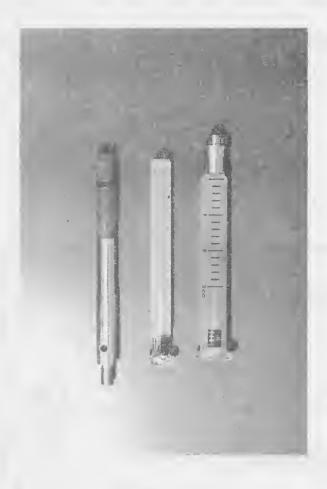
Exhibit 3. Hypodermic syringe, showing glass cylinder, glass plunger, and first stainless steel plunger.

The plunger and cylinder used on the first breadboard design had been a glass hypodermic syringe (shown in Exhibit 3, along with the first stainless steel plunger) with an inside diameter of 0.351 inches. As the buffer solution evaporated, crystals deposited on the ground glass cylinder wall and the piston jammed.

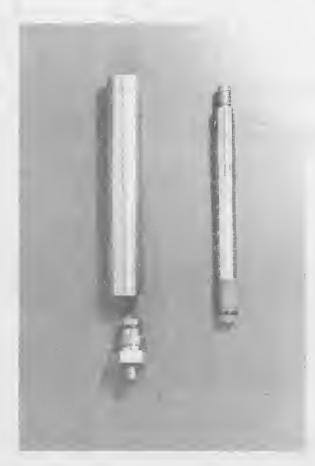
Exhibit 4. First production model stainless steel cylinder and plunger. Hexagon fitting was added to make cleaning easier. A "Rulon" insert was added as shown in Exhibit 5 to provide a second contact surface for the plunger to ride on.

Successive models were tested (see Exhibits 4 and 5) using a variety of piston and cylinder materials with o-ring seals. The most effective proved to be a smooth bore (honed to 4-6 min. finish) stainless cylinder with a stainless steel piston equipped with a Rulon¹ tip and a buna "N" o-ring. After evaluation by the Beckman Applications Research Section, this design was released for production.

After he had acquainted himself with the design history of the pump, Chet examined the production model and talked with Field Service Department personnel in an attempt to determine the causes of failure. Most of the people he consulted felt that the problem lay in the type of seal chosen for the plunger. They found that the rubber o-ring was badly abraded on all of the pumps they had checked. There were several opinions expressed about the cause of this condition, but Chet thought that two modes of failure seemed most likely: 1) some of the organic solvents might be causing the o-rings to deteriorate; and 2) a thin film of fluid remaining on the cylinder wall might dry and leave an abrasive surface to wear down the o-rings.

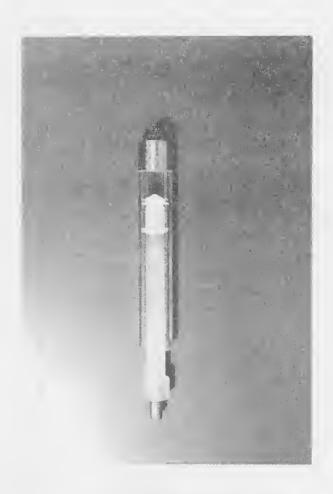
Exhibit 6. 'Wiper ring' plunger seal design. Rings are machined on the Teflon tip as shown on the sketch below.

The first of Chet's two plunger designs is shown in Exhibit 6. It consists of a Teflon tip attached to a "Kel-F" plastic shank. Three "wiper rings" were machined into the Teflon tip to act as seals and guides. By providing an interference fit between the wiper rings and the glass cylinder, he hoped to minimize leakage past the inert Teflon. After three days of continuous testing, using water as the test solution, the wipers began to leak. Chet measured the outside diameters of the wipers and found that they had shrunk. This was apparently due to cold flowing of the Teflon.

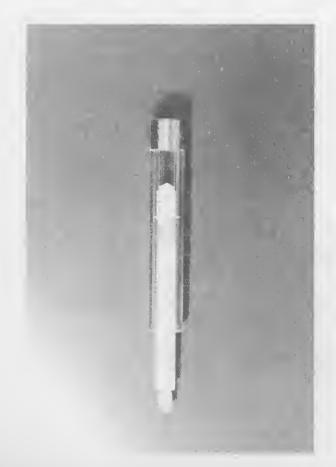
Exhibit 7. So-called "lip seal" plunger seal design.
A cross-section of the Teflon tip is shown below.

Chet's second plunger seal redesign is shown in Exhibit 7. He had a "lip seal" machined into a Teflon tip which had an interference fit with the glass cylinder wall. This seal was intended to expand outward against the cylinder wall when pressure was applied to the chamber fluid. This design, however, began to leak soon after it was installed in the pump. Chet believed that this was due to cold flowing of the Teflon which had caused the lip seal to pull away from the chamber walls at low pressures.

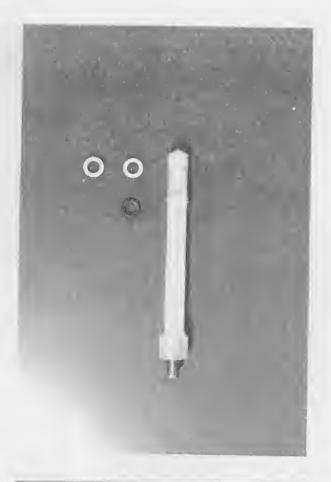
Exhibit 8a. Assembled test plunger. Note the spiral wiper ring installed below the plunger tip. Some of the sealing rings tested are, from left to right, top to bottom, a slotted Teflon ring with a spring insert, a pure Teflon o-ring, and a Teflon coated rubber o-ring.

Chet next tried o-rings made of Teflon. Since these rings could not be stretched into mounting grooves as could conventional rubber o-rings, they could not be tested on the existing steel plunger. Chet devised a test plunger (Exhibit 3) which would accommodate several types of Ieflon rings. The Kel-F plastic tip of the plunger was threaded so that it could be screwed down against the o-rings to hold them on the plunger. A spiral Teflon wiper ring was mounted around the middle of the plunger to act as an additional guide and seal. Chet chose the spiral Teflon ring because 1) the Teflon would not swell upon contact with a buffer (as does rubber); and 2) a spiral ring could be installed on the shank of the plunger without the necessity of fabricating it to screw apart to accommodate an ordinary o-ring.

Chet tested three types of rings: a Teflon coated rubber ring, a slotted Teflon ring with a spring insert to provide a sealing force (Exhibits 7b and 7c), and a plain slotted Teflon ring. The Teflon coated rubber o-ring began to swell after two days of continuous operation. After disassembling the plunger, Chet found that the Teflon coating had worn off, thus exposing the base rubber to the buffer solution. The plain slotted o-ring began to cold flow and leaked soon after it was installed. The slotted ring with a spring insert leaked due to insufficient spring strength to affect sealing.
